CONCRETE SLAB EDGE REPAIRS WITH POST-TENSIONING ANCHORS

BY DONALD CHALAIRE

At the building owner's request, we reviewed repair procedures during balcony slab edge spall repairs on their high rise residential building that was built in 1986 in West Palm Beach, FL. This is a structure with waterfront exposure. A separate engineer and contractor had been hired for the concrete spall repairs. The engineer reported that in addition to the slab edge spalls, exposed post-tensioning (PT) anchors at the slab edge were significantly deteriorated, causing a structural integrity issue. During the repairs, seven PT anchors were replaced. The PT replacements required interior slab excavations to install temporary load lock offs. The purpose of our review was to provide a second opinion regarding the need for PT repairs. We observed the work during the repairs and took the removed PT anchors away with us.

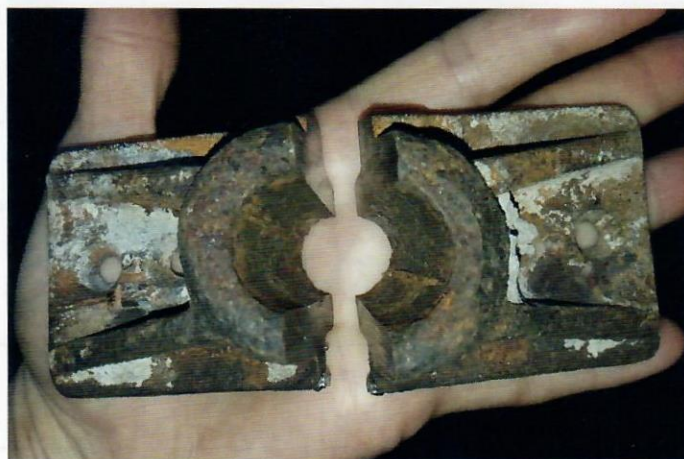
Fig. 1—Specimen No. 1: anchor, nonbearing front side.

Specimen No.	1	2	3	4	5	6	7
General	The anchor, wedge, and strand were saw-cut in half (Fig. 1)	The wedges and strand were machine pressed out of the anchor (Fig. 9 and 10). The wedges stayed attached to the strand (Fig. 11, and 12)	The anchor, wedge, and strand were left intact	The anchor, wedge, and strand were left intact	The anchor, wedge, and strand were left intact	The anchor, wedge, and strand were left intact	The anchor, wedge, and strand were left intact ²
Strand in tendon		Lightly oxidized with no loss of cross-sectional area	No loss of cross-sectional area	No loss of cross-sectional area	No signs of rust or deterioration	No signs of rust or deterioration	
Bearing side of anchor	Minor pitting approximately 0.005 in. deep (Fig. 3)	Very minor pitting approximately 0.005 in. deep	Surface rust and outer edges with pitted areas approximately 0.06 in. deep (Fig. 15)	Surface rust at the edges only and pitted areas of 0.06 in. in some areas (Fig. 17)	Surface rust at the edges only (Fig. 19)	Surface rust with minor pitting around the edges only approximately 0.005 in. deep (Fig. 21)

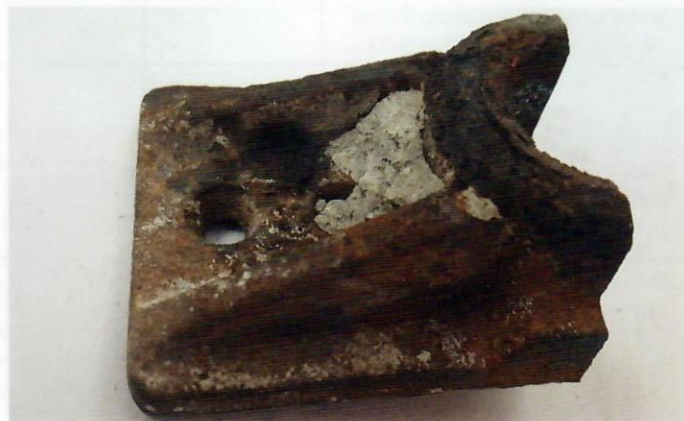
Fig. 2—Specimen No. 1: anchor, nonbearing front side.

Wedge cavity	Minor pitting <0.005 in. deep (Fig. 4)	Very minor pitting <0.005 in. deep (Fig. 13)					
Nonbearing front side of anchor	Minor pitting approximately 0.005 in. deep (Fig. 2)	Minor pitting approximately 0.005 in. deep	Rust scale mostly at the outermost surface at the barrel	Minor pitting and scaling, mostly at the outer edges with pitting approximately 0.005 in. deep	Minor pitting and scaling; the pitting is approximately 0.005 in. deep	Minor pitting approximately 0.005 in. deep	
Wedge outside surface	Minor pitting <0.005 in. deep	Very minor pitting <0.005 in. deep					
Wedge inside surface	Clean serrated teeth intact along the cut (Fig. 5-7) ¹						
Strand tail in front of anchor	Significantly deteriorated	No loss of cross-sectional area	Significantly deteriorated (Fig. 14)	No loss of cross-sectional area (Fig. 16)	Deteriorated with approximately 30% loss of cross-sectional area (Fig. 18).	No loss of cross-sectional area (Fig. 20)

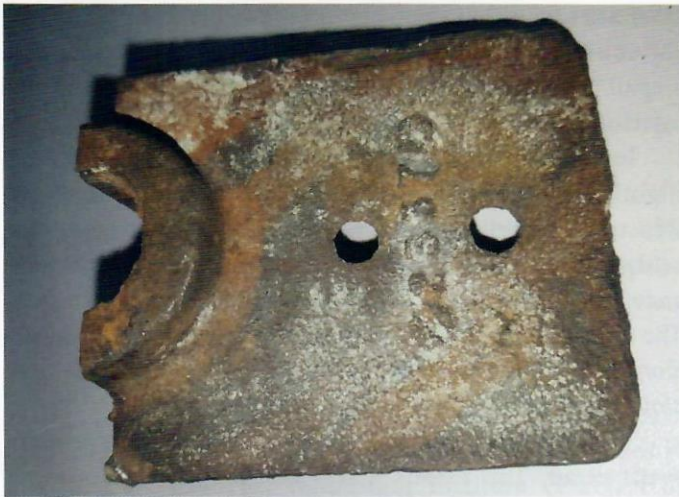
Fig. 3—Specimen No. 1: anchor, bearing side.

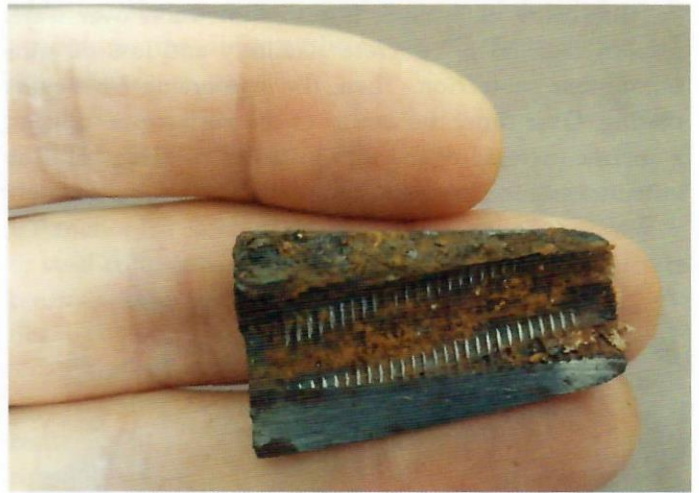
Fig. 6—Specimen No. 1: wedge serrated teeth.

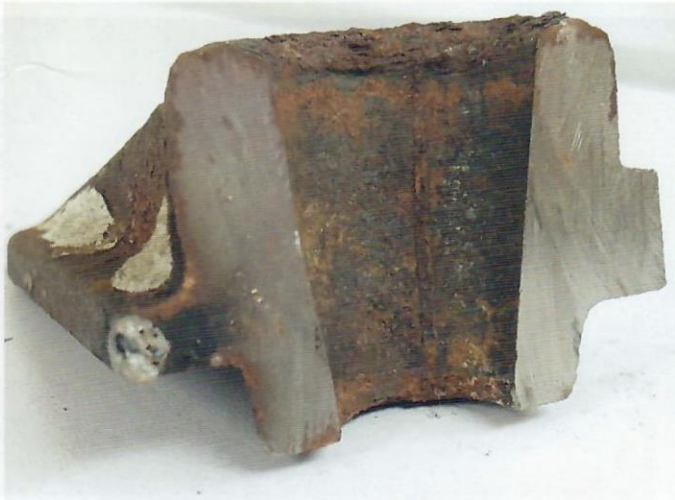
Fig. 4—Specimen No. 1: anchor cross section.

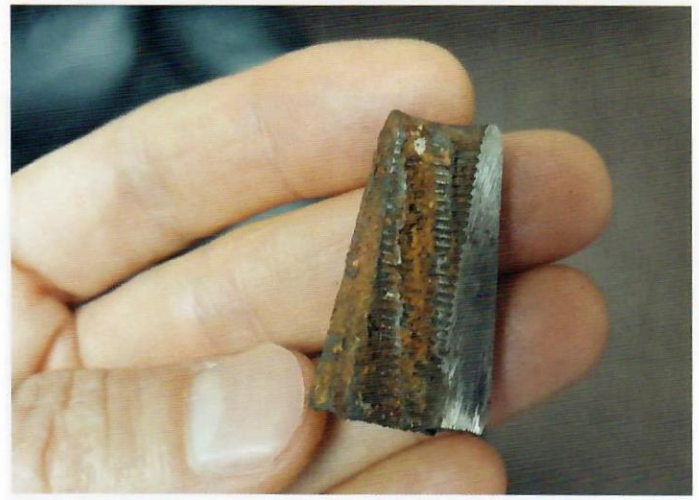
Fig. 7—Specimen No. 1: wedge serrated teeth

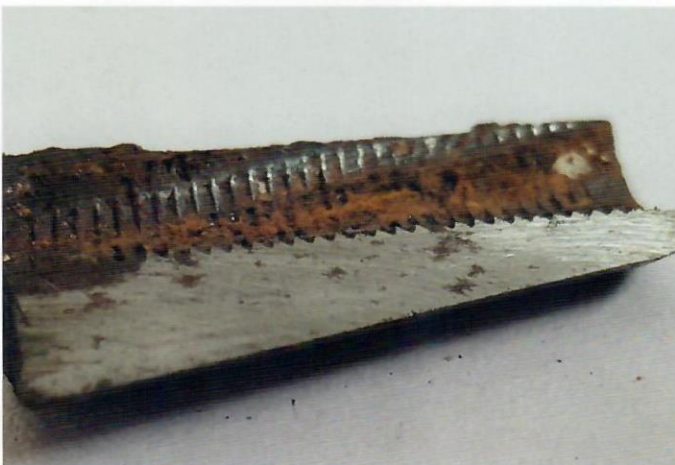
Fig. 5—Specimen No. 1: wedge cross section.

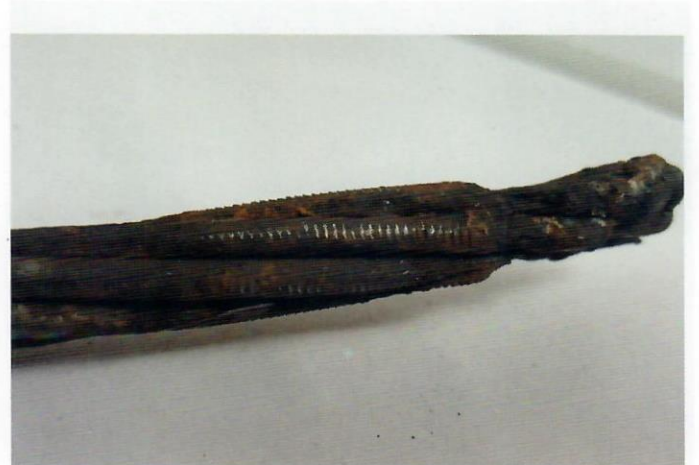
1. The serrated teeth that did not contact the stranded are covered in scale the same height as the teeth. The cable strands on the load side of the anchor show clear bite marks from the wedge teeth with no rust and no loss of cross-sectional area. (Fig. 8)

Fig. 8—Specimen No. 1: strand bite marks from wedge.

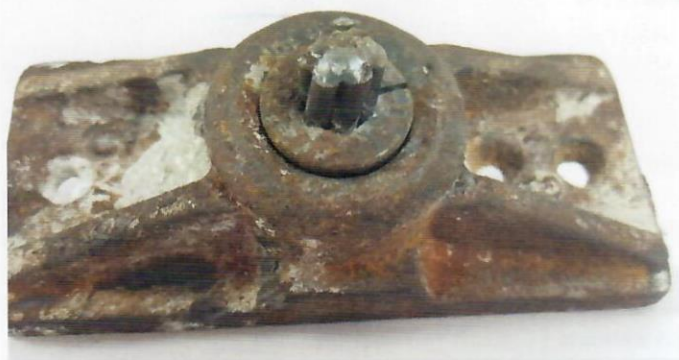
Fig. 9—Specimen No. 2: anchor, nonbearing side.

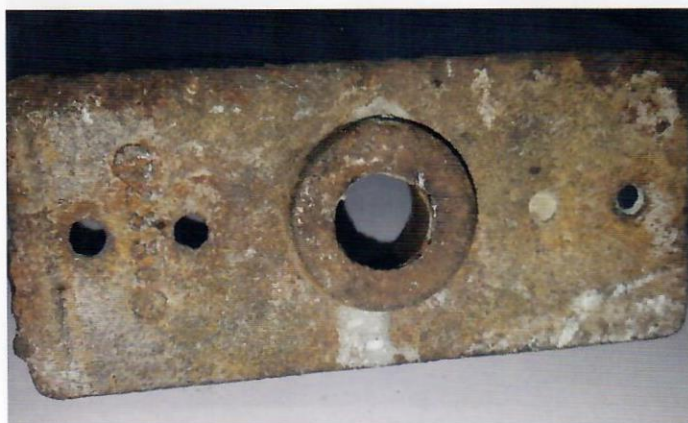
Fig. 10—Specimen No. 2: anchor, bearing side.

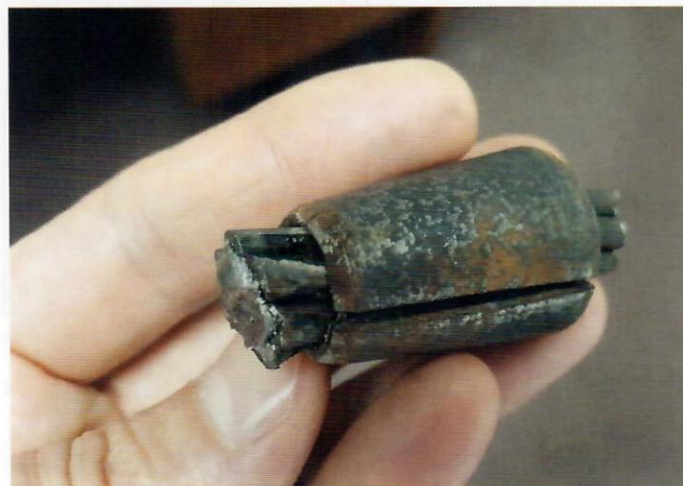
Fig. 11—Specimen No. 2: wedge and strand.

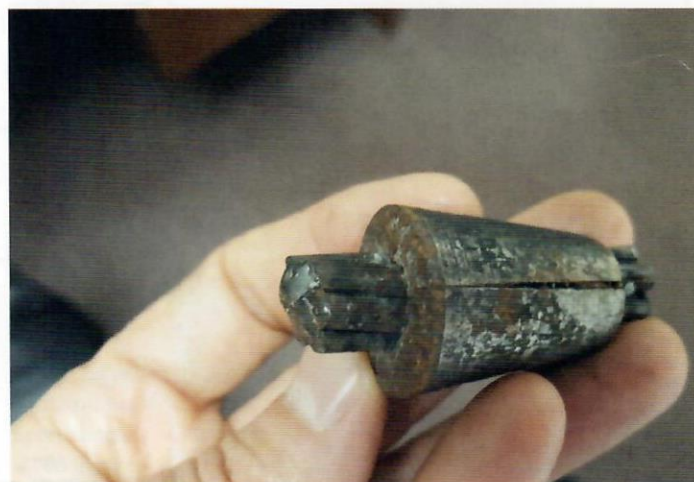
Fig. 12—Specimen No. 2: wedge and strand.

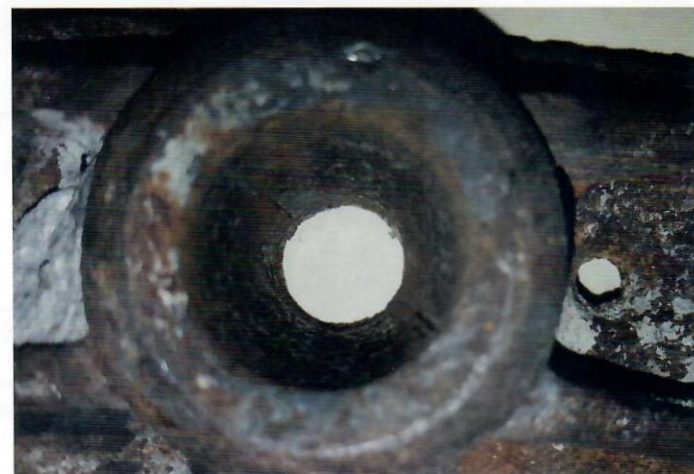
Fig. 13—Specimen No. 2: anchor, inside surface of wedge cavity.

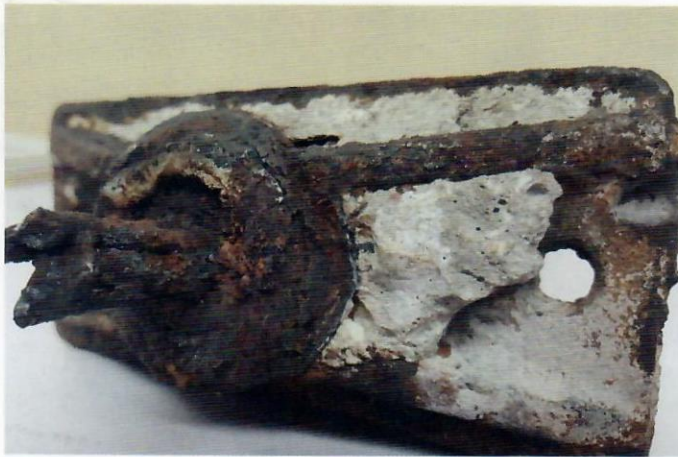
Fig. 14—Specimen No. 3: anchor, nonbearing side.

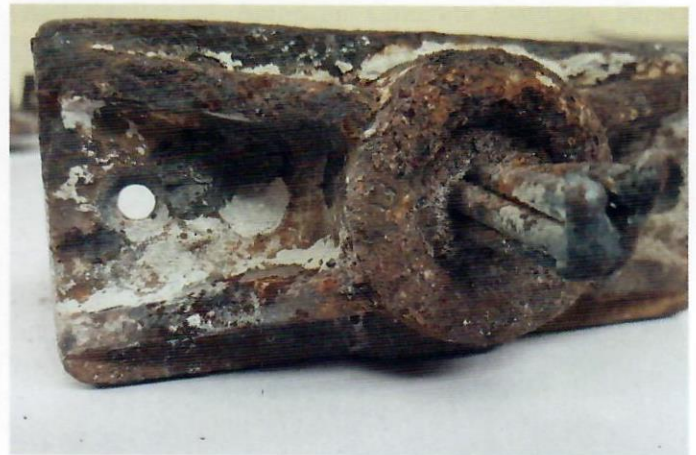
Fig. 16—Specimen No. 4: anchor, nonbearing side.

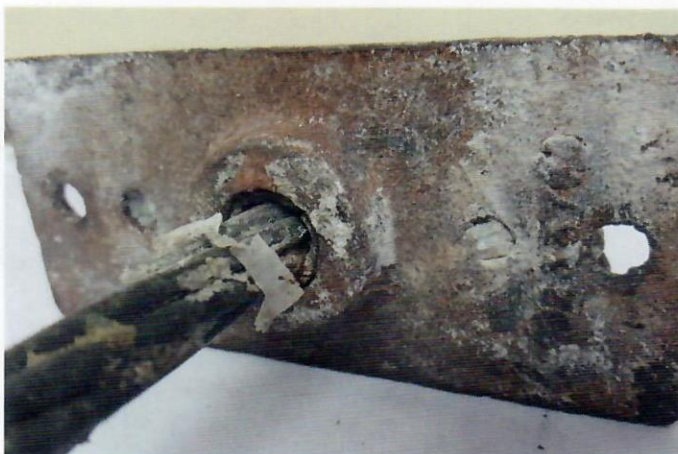
Fig. 15—Specimen No. 3: anchor, bearing side.

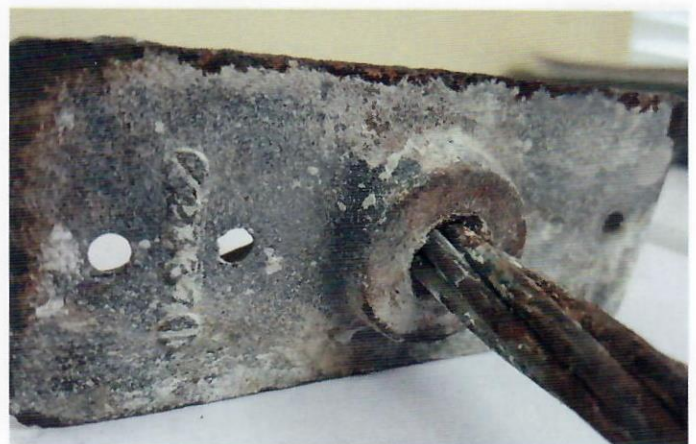
Fig. 17—Specimen No. 4: anchor, bearing side.

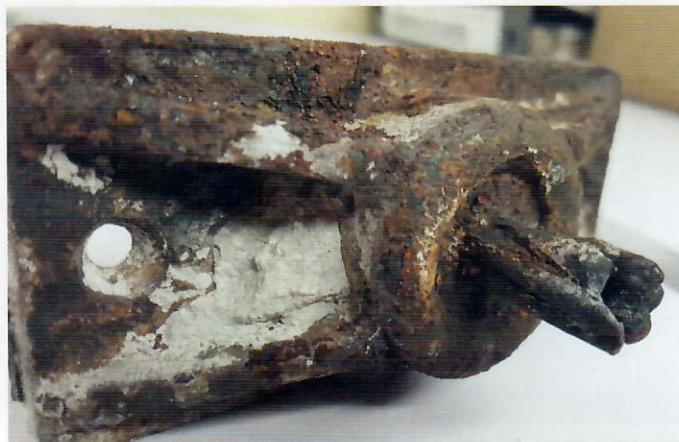
Fig. 18—Specimen No. 5: anchor, nonbearing front side.

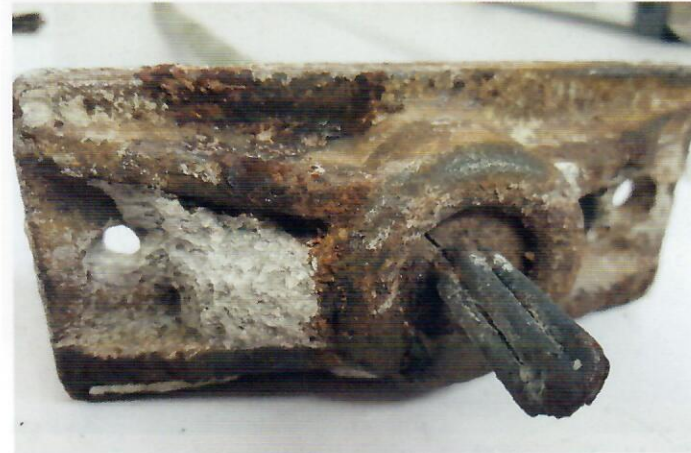
Fig. 20—Specimen No. 6: anchor, nonbearing front side.

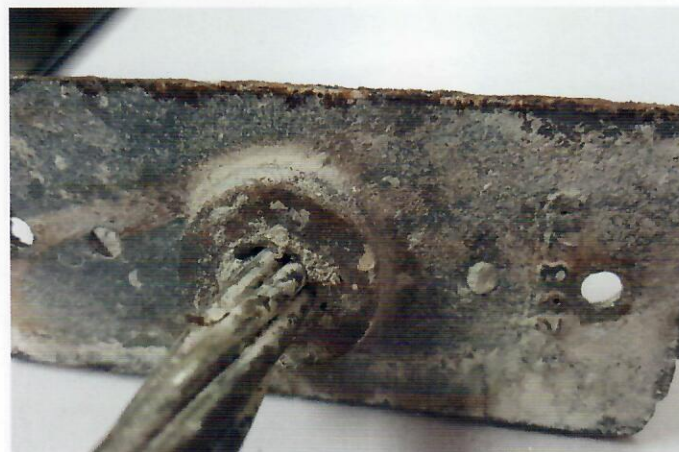
Fig. 19—Specimen No. 5: anchor, bearing side.

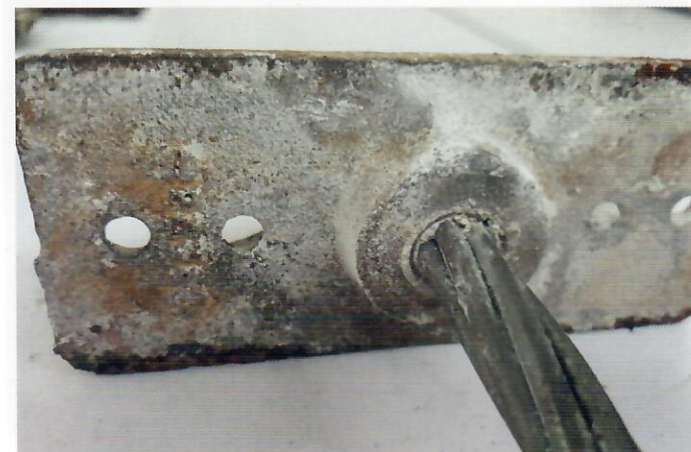
Fig. 21—Specimen No. 6: anchor, bearing side.
